FREQUENCY EFFECTS ON FATIGUE BEHAVIOR
OF A UNIDIRECTIONAL METAL MATRIX
COMPOSITE AT ELEVATED TEMPERATURE

THESIS

In Partial Fulfillment of the
Requirements for the Degree of
Master of Science in Aeronautical Engineering

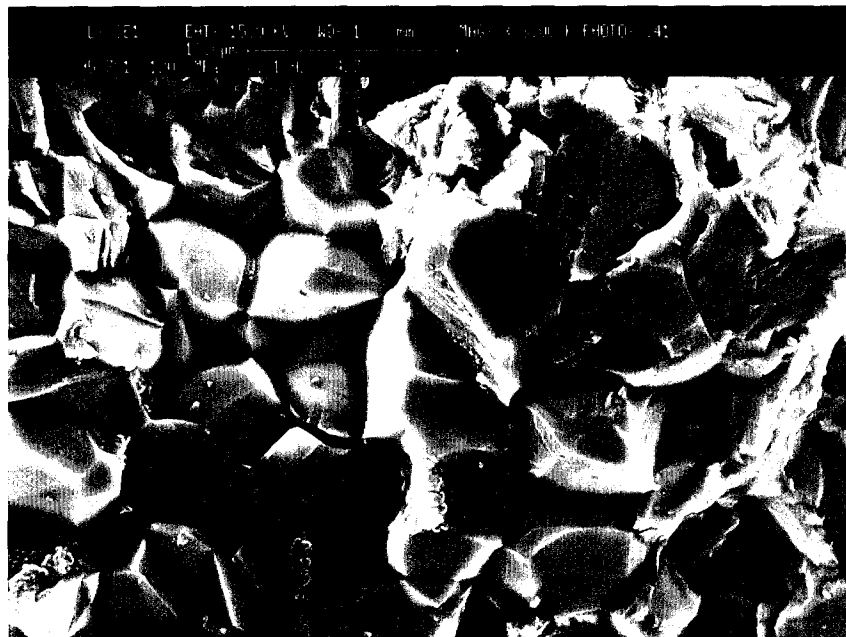
Figure 4.22 Oxidation Precipitates on Grains. 1200 MPa, 0.01 Hz, 427°C (3000x)

A third cracking mechanism observed was intergranular decohesion, which is prevalent in high oxidation and creep environments. This mechanism is evidenced by gaps between the grains and well-defined, faceted grain boundaries. Figure 4.21 depicts intergranular decohesion observed in a ring around a fiber, and a transition to transgranular cleavage further from the fiber, and Figure 4.22 shows a region in an edge crack where transgranular cracking is present with oxidation precipitates visible on some

of the grains. In the specimen cycled at 0.01 Hz, intergranular decohesion was only observed in rings around a few fibers, which was possibly caused by carbon from the fibers that diffused into the matrix during laminate fabrication.
